WILDFIRE-ASSOCIATED LANDSLIDE EMERGENCY RESPONSE TEAM REPORT

Eagle Bluff Fire

Okanogan County, Washington

WASHINGTON
GEOLOGICAL SURVEY
WALERT Report
September, 2023

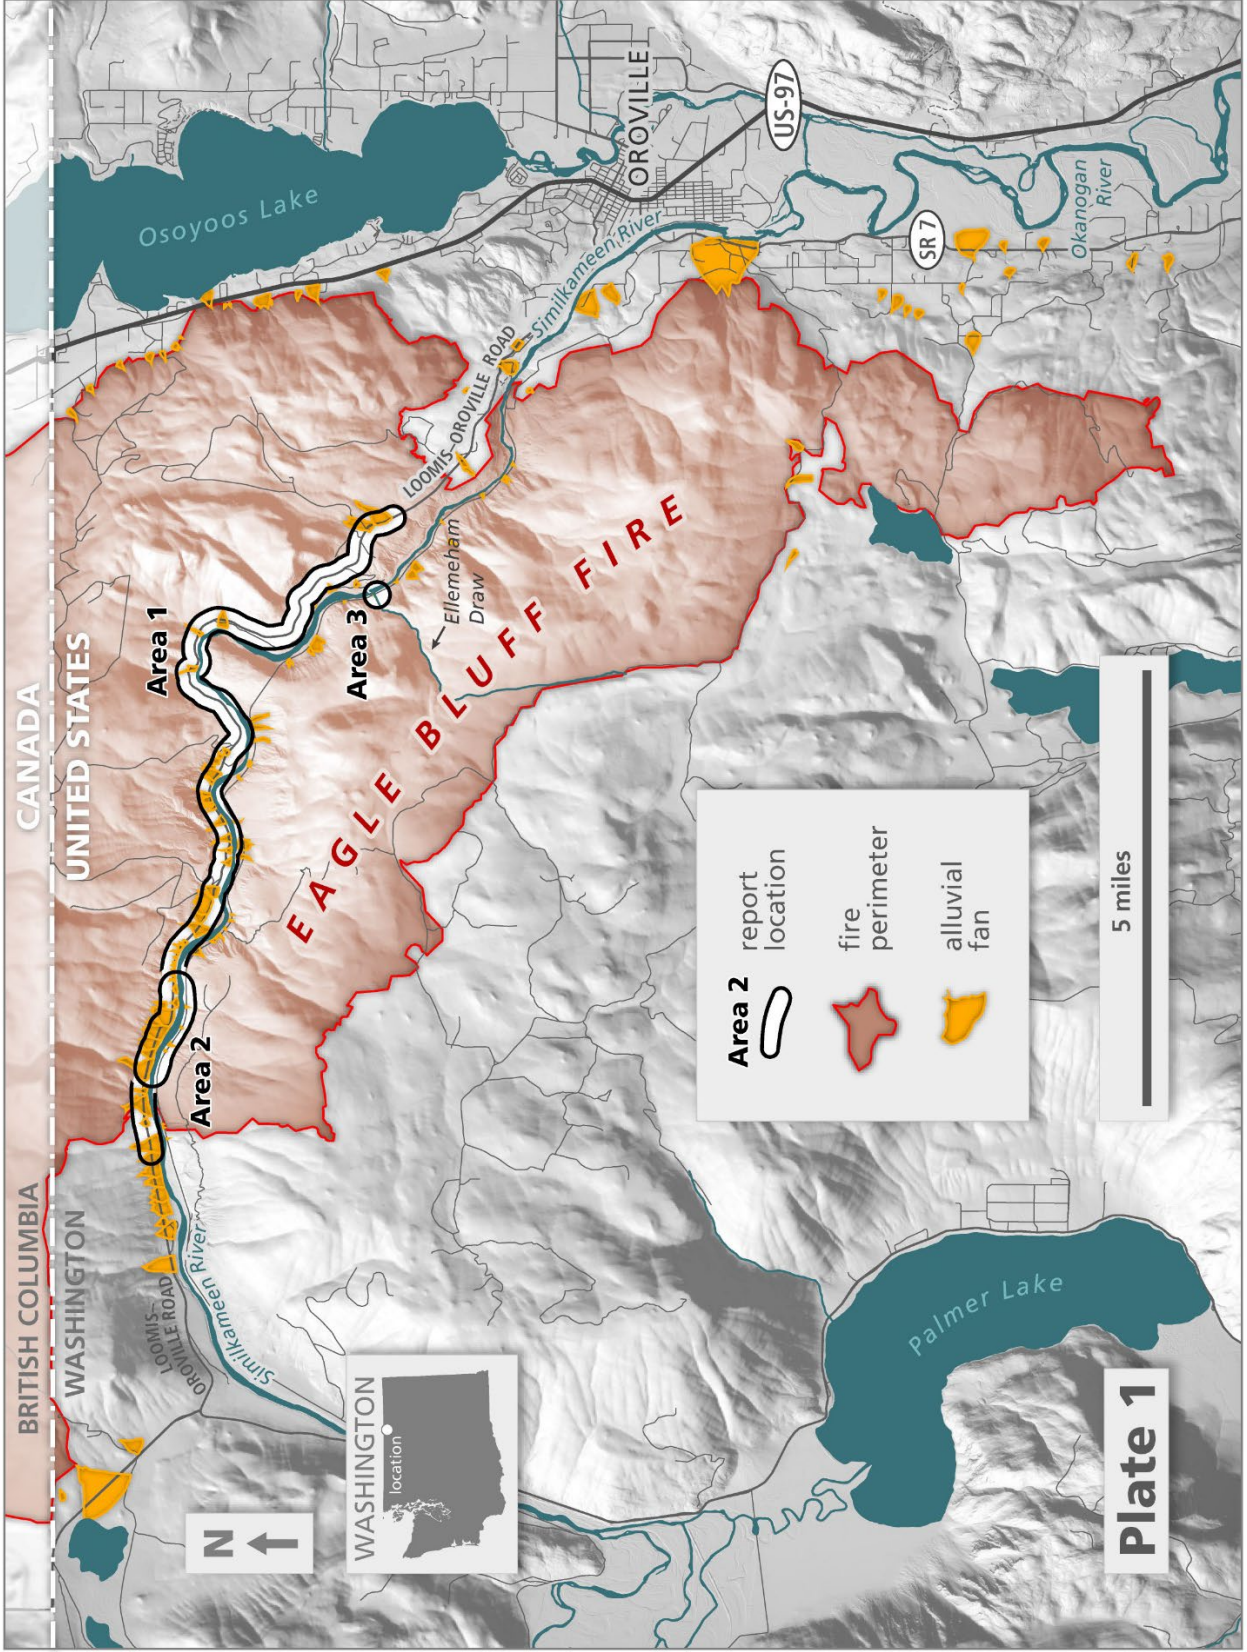
Plate 1. Highlighted locations mentioned in this report for the Eagle Bluff Fire

Several fans are identified along the east-facing slopes along the eastern fire boundary, west of US Route 97 (Plate 1). USGS modeling indicates Low and Moderate debris flow hazards in hydrologic basins upslope of these landforms. For many of these fans, surficial features providing evidence of historic hazards have been obscured by agricultural land use. However, future flooding may impact agricultural lands in these areas.

Loomis–Oroville Road (Area 1 on Plate 1)

Loomis–Oroville Road is built across several south-facing fans and talus slopes along the northern side of the Similkameen River. The USGS modeling indicates a Low debris flow hazard for basins upstream of fans and the roadway. Unconsolidated deposits of glacial drift compose much of the basins that contribute to these fans, especially above fans with activity observed in this review. Steep slope gradients and inferred high rates of erosion within these unconsolidated deposits prohibit the establishment of vegetation, and thus these basins did not appear to experience much fire activity. Remote review of historical aerial imagery reveals several flooding and potential debris flow events over the last several decades based on apparent erosion of vegetation or soil in stream channels, or debris deposition on mapped fan surfaces. Recent debris-clearing activities and excavations along many sections of this roadway further support the remote and field observation that flooding and potential debris flows have historically posed a hazard, even prior to the fire. Mobilization of debris during storm events can plug culverts and potentially lead to public safety threats, washouts of the roadway, or increased flooding impacts.

Dispersed camping areas (Area 2 on Plate 1)

The *Similkameen Recreation Site* and *Cutchie #4 Public Access* areas are two dispersed camping sites managed by BLM within mapped fan deposits, downslope of the Loomis–Oroville Road. Based on debris flow modeling, remote

observations, and field reconnaissance, flash flooding and debris flows could impact portions of these camping areas.

Enloe Dam (Area 3 on Plate 1)

The Enloe Dam is located on the Similkameen River approximately 5.3 river miles northwest of Oroville. The dam site is on BLM land and is owned and managed by the Okanogan County PUD. Some of the dam infrastructure is positioned at and adjacent to the Ellemeham Draw, an ephemeral stream channel that joins the Similkameen River directly downstream of the dam. Remote and field reviews did not identify historic evidence of debris flow events within or emanating from the Ellemeham Draw or impacting the Enloe Dam site. USGS debris flow modeling indicates that there are low to moderate debris flow hazards within tributary basins to the Ellemeham Draw, which can translate to flooding within the draw. These hazards could impact the steel penstocks and small bridge located at the mouth of the draw. Occurrence of flash flooding within the draw will be at an elevated risk over the next several years such that flood waters and debris associated with debris flows or debris currently sitting in the channel may impact dam infrastructure at the mouth of the draw.

Our assessment suggests that flash flooding and debris flow hazards have occurred in some areas evaluated in this assessment prior to the fire and will likely occur in future storm events within the burn area. Debris flows, flash flooding and increased runoff could impact infrastructure during periods of intense precipitation (approximately one-quarter inch of rain in a 15-minute period), atmospheric river events,¹ or rain-on-snow events.²

Managers of transportation networks and private landowners should be reminded of the increased likelihood of sediment transport, sediment deposition, and (or) erosion impacts to roads following wildfires, as well as potential issues with blocked culverts. We further recommend inspecting culverts within channels draining areas impacted by the fires both before and after storm events, specifically along Loomis–Oroville Road and the dam infrastructure at the mouth of the Ellemeham Draw. Blocked culverts can cause additional flooding and damage, which could otherwise be minimized by being proactive about clearing these culverts.
